CCGS PROVO WALLIS Condition and Valuation Survey

Project 6971
04 August 2011

PROVO WALLIS is a 64m x 13m (209' x 42.5') Canadian Coast Guard buoy tender and light icebreaker. She is surplus to the department's operational needs. This report describes her condition, and offers an opinion of the value of the vessel as is-where is, and as scrap steel.

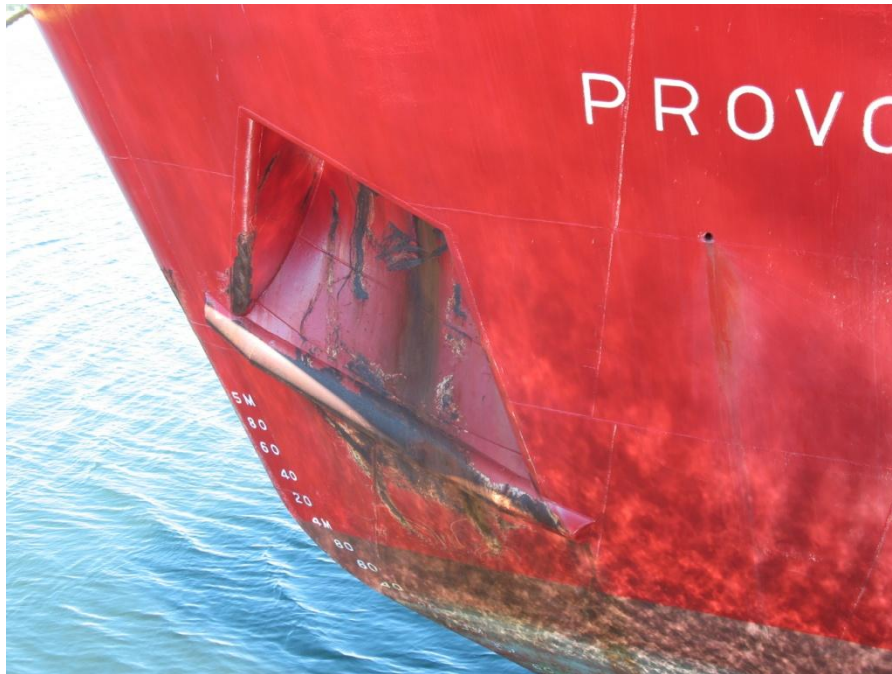
The port anchor pocket boundaries are worn down from chain wear and the bottom ½ round is deformed. These items are considered normal wear and tear, and are not considered to be structurally significant.

Figure 3: Anchor pocket, port bow.

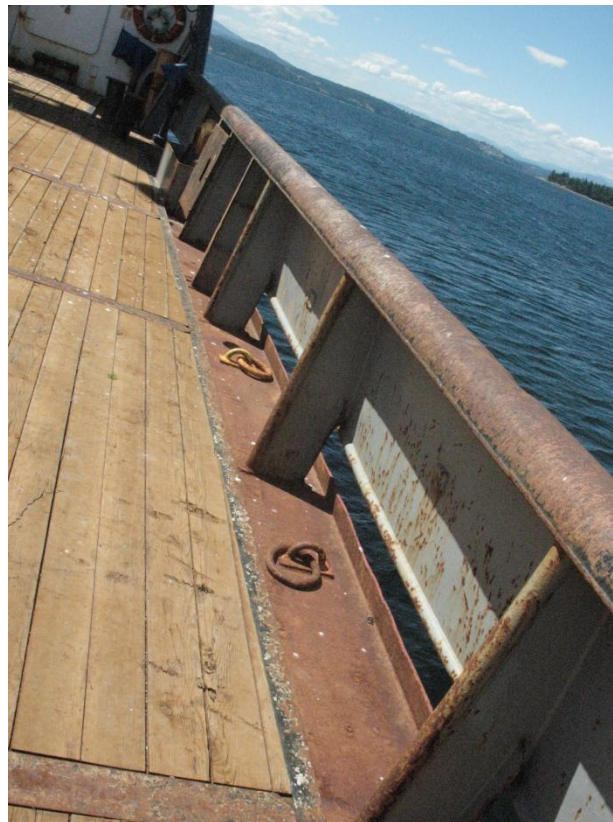
The wood decking on the well deck appears almost new and is in excellent condition; it is reported to be one year old. The steel deck underneath was not available for viewing, but the

steel deck plate on the perimeter of the wood working deck was in reasonable condition with only “working surface rust” showing.

Figure 4: Well deck bulwarks, stringer plate, and wood decking

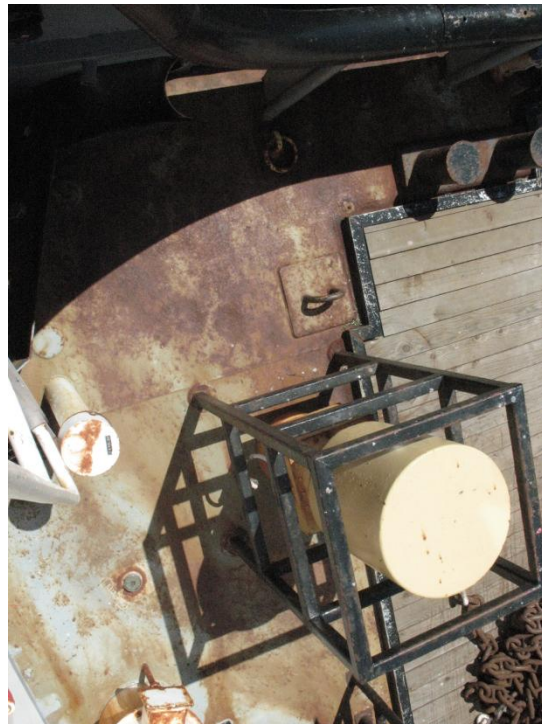
There is some perforation of the gunwale bar at the aft end of the well deck. As above, this is not significant.

Figure 6: Port aft corner of well deck

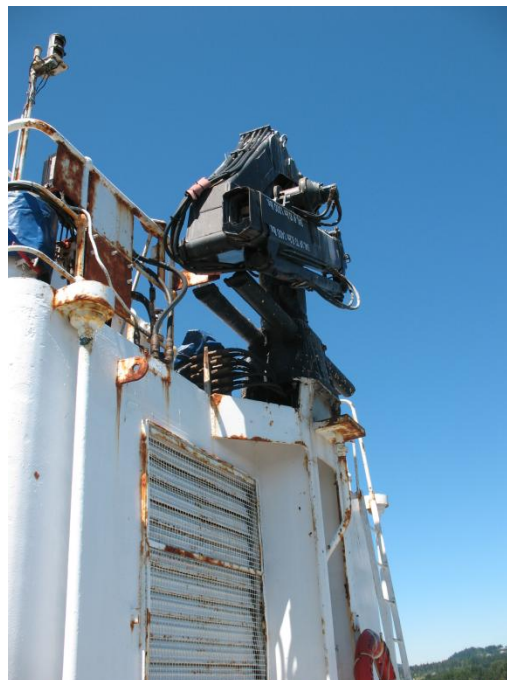
The Hiab knuckleboom stores crane at the aft end of the superstructure appears to be in satisfactory condition with no visual defects of concern.

Figure 8: Stores crane and aft bhd of emerg. gen. compt. on boat deck

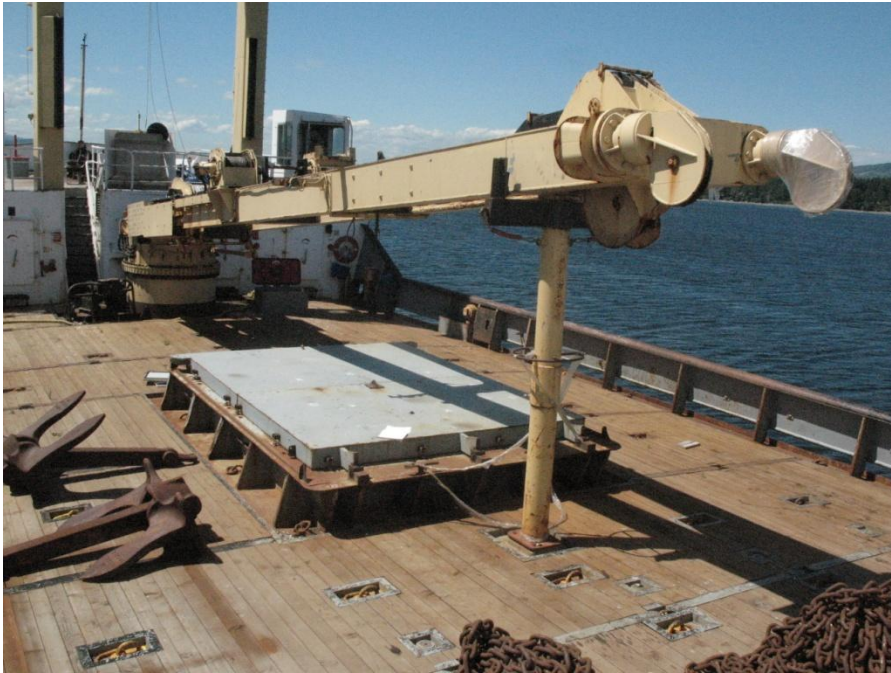
Both anchors and one chain are laying loose on the well deck. One anchor chain appears to be missing from the vessel.

Figure 9: Buoy Derrick, main hatch, well deck, and anchors

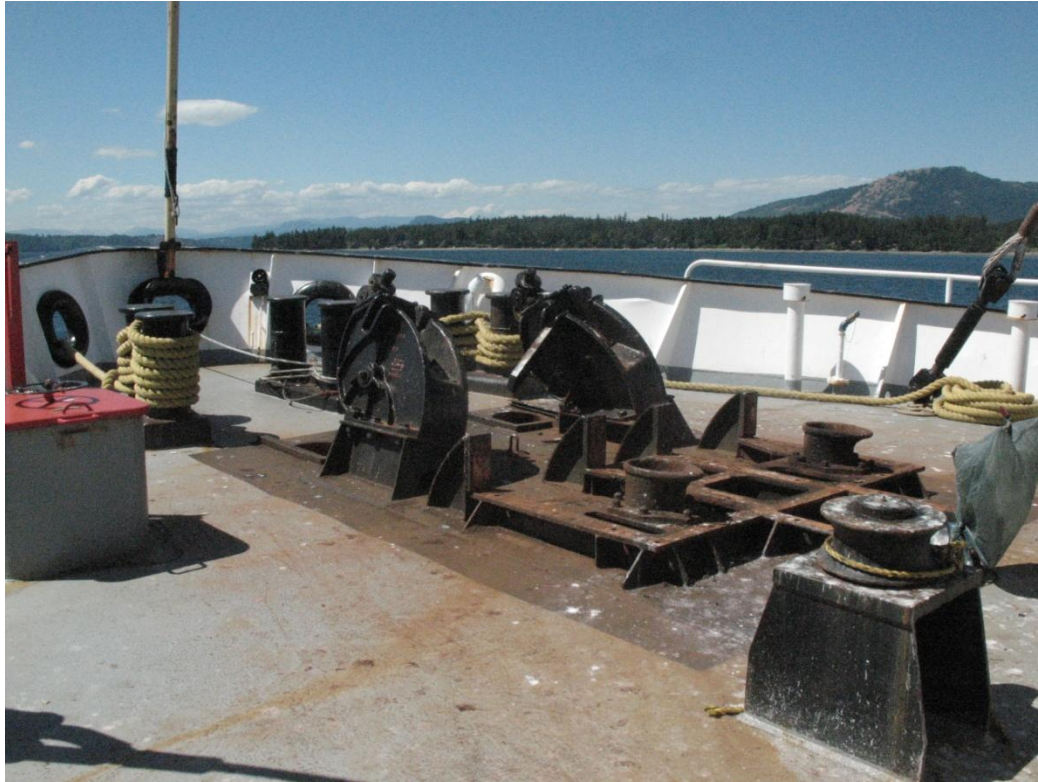
The windlass on the foc'sle weather deck has been removed. Owner intends to place it aboard the vessel, loose on deck, in preparation for the sale of the vessel. The windlass was not available for viewing, but is reported to have undergone recent maintenance/component renewal work, and to be in good order.

Figure 11: Windlass bedplate, chain stoppers, fairleads on foc'sle

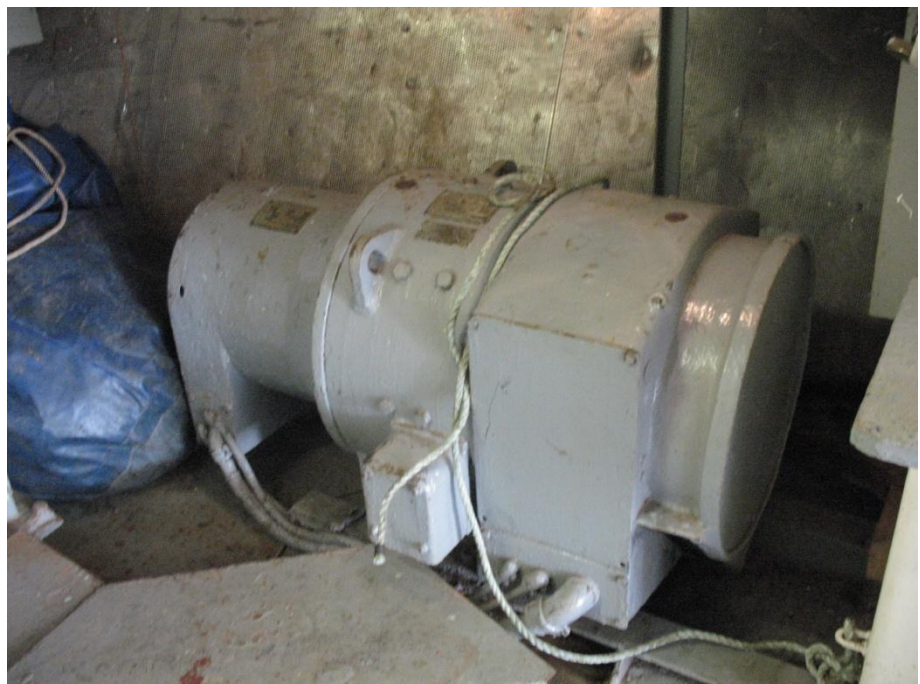
The M-G set appears to be in good order; no external sign of overheat or sparking.

Figure 12: Windlass MG set in foc'sle

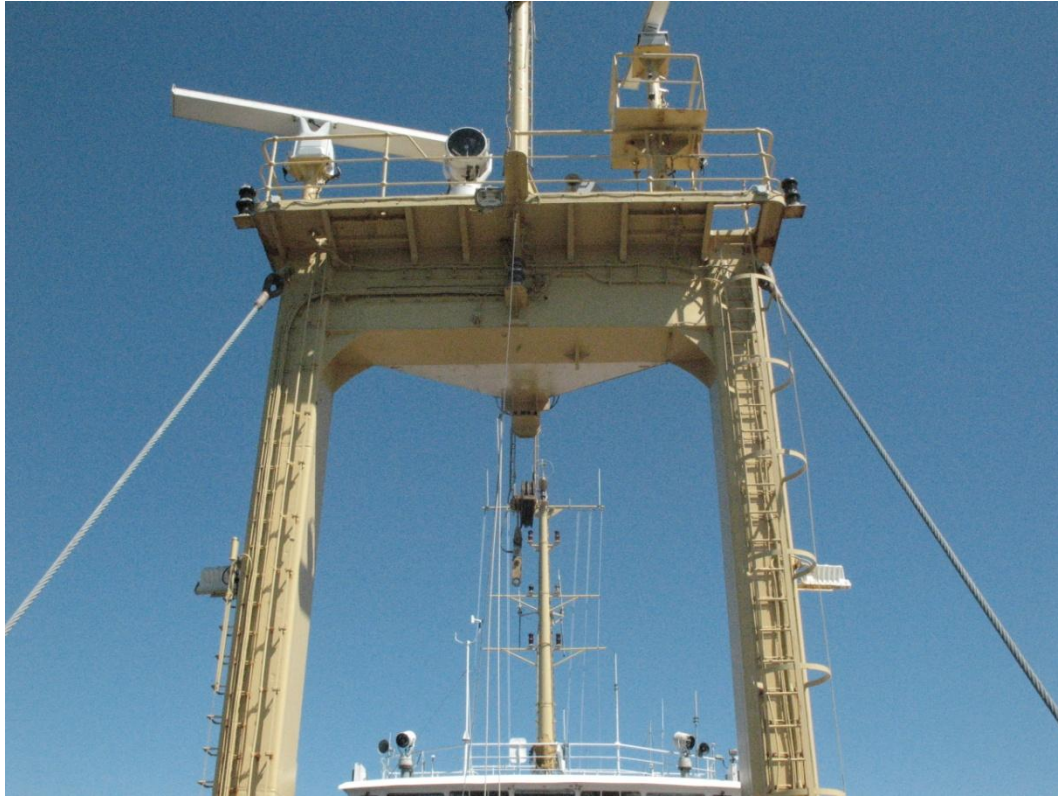
The mast appears to be in sound condition, with only minor rust at some cable conduit hangars. All blocks, shackles, and wire tackles have been un-rigged and are not aboard the vessel. The two operators' cabins for the buoy derrick are dry, show normal signs of use, and no damage to them was noted. No tests of the derrick controls were undertaken.

Figure 13: Mast structure, looking aft

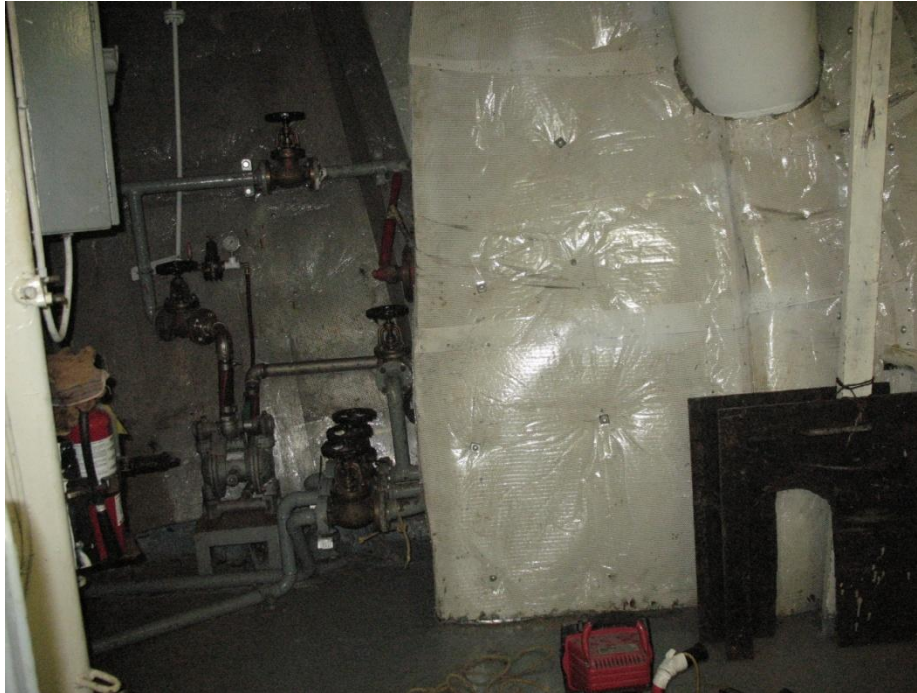
Figure 15: Foc'sle interior, looking at the port anchor pocket

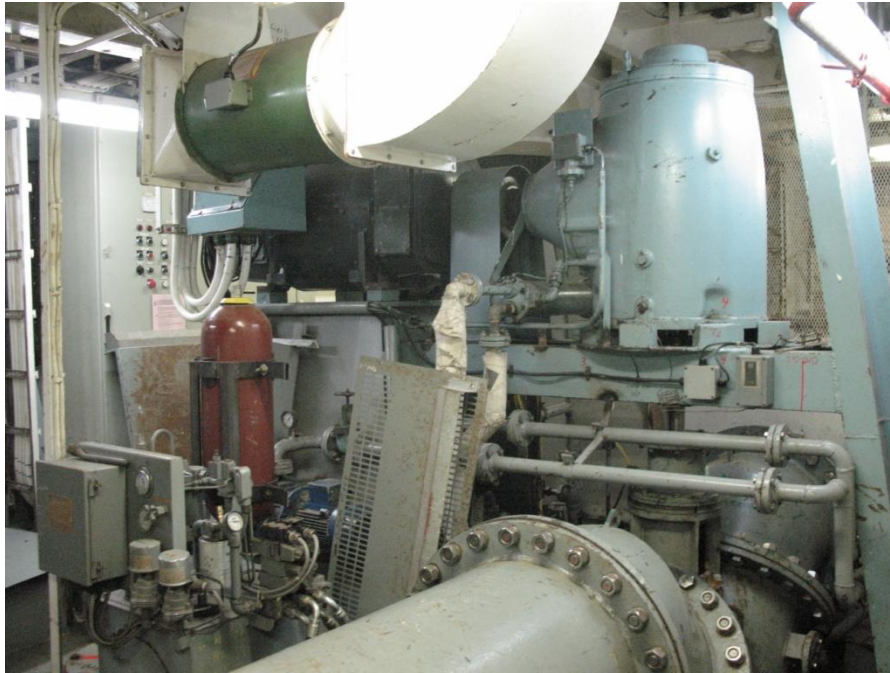
The bow thruster is an OMNI bi-directional unit of 400 hp with tunnel discharges just below the waterline. Suction is a sea bay at the keel. The thruster impeller is driven through a right-angle drive via a Siemens variable speed DC controller. The motor is separately fan-cooled.

Figure 17: Bow thruster compt.---motor, right-angle drive, control cabinet, discharge tubes

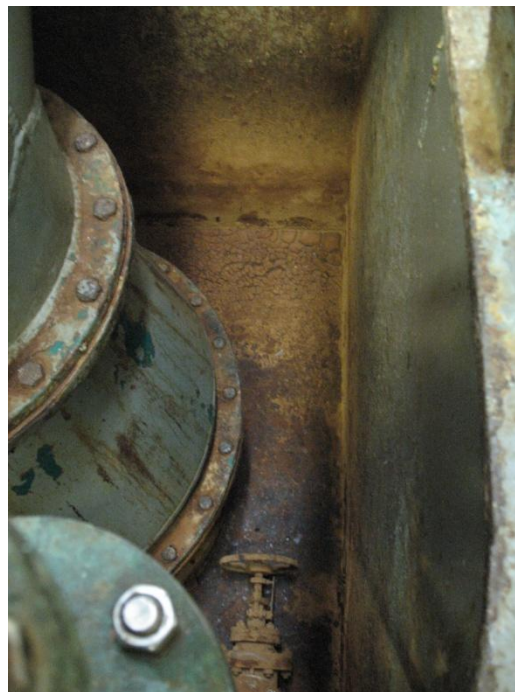
The thruster suction bay is corroded evenly overall at its bottom (no ultrasonic thickness data is known to the author). The thrust produced by the OMNI unit was measured a year ago at 3600

lbs (1630 kgf) +/- . The suction well plate condition is as expected for a splash/drip zone area around the thruster's impeller shaft packing gland.

Figure 18: Bow thruster sea bay suction well

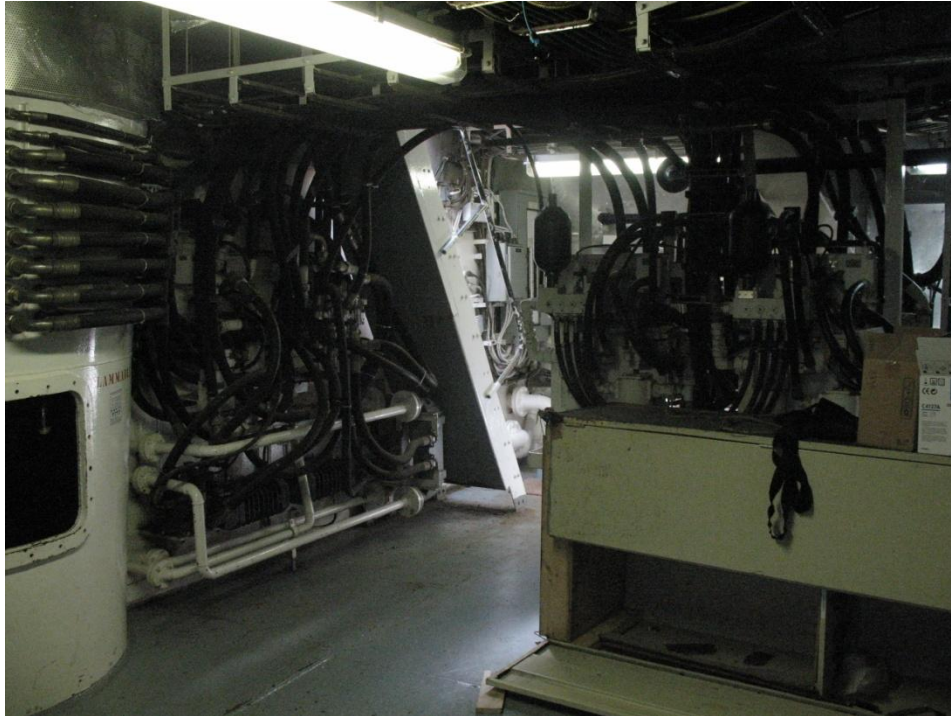
The derrick machinery space contains the 4 hydraulic pumps and the valves and hoses for operating the buoy derrick. The machinery appears to be in good order. Hoses and fittings appear to be well made-up and properly chafe-protected where necessary. There is no indication of noticeable oil leaks.

Figure 19: Derrick machinery/hydraulic compartment

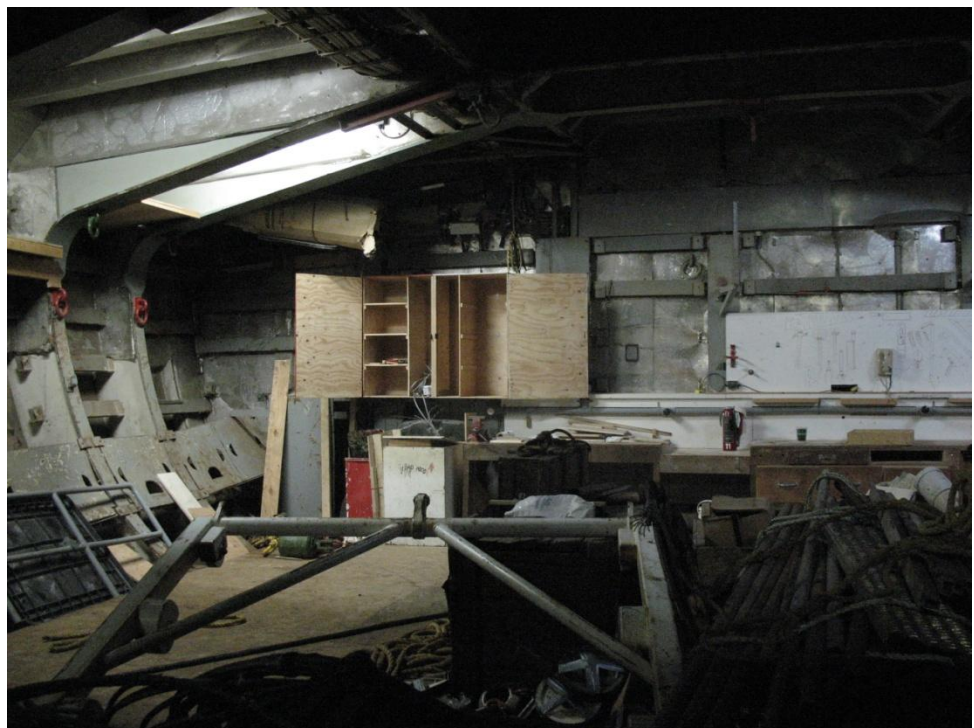
The hold is structurally in good condition. There is some minor corrosion at the base of a few frames on the starboard side which is not considered significant.

Figure 20: Hold, starboard side, looking aft

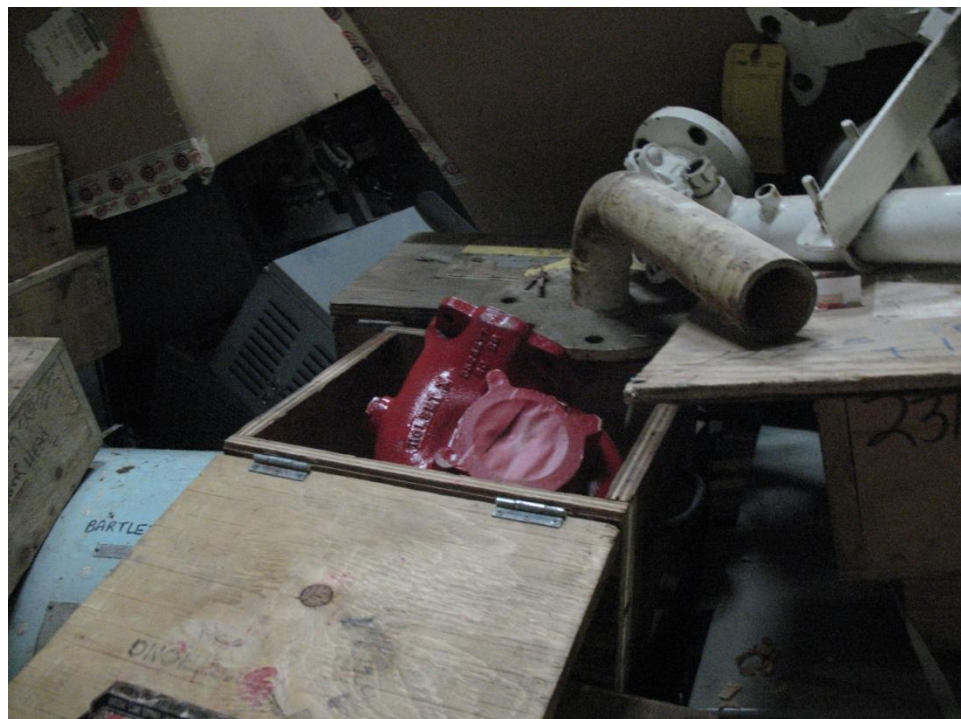
The hold is cluttered with a loose accumulation of spare parts, pipe sections, and miscellaneous equipment. No specific cataloguing was undertaken. The collection is typical of a vessel in service for many years, and some items can probably be consigned ashore.

Figure 22: Typical spares in hold

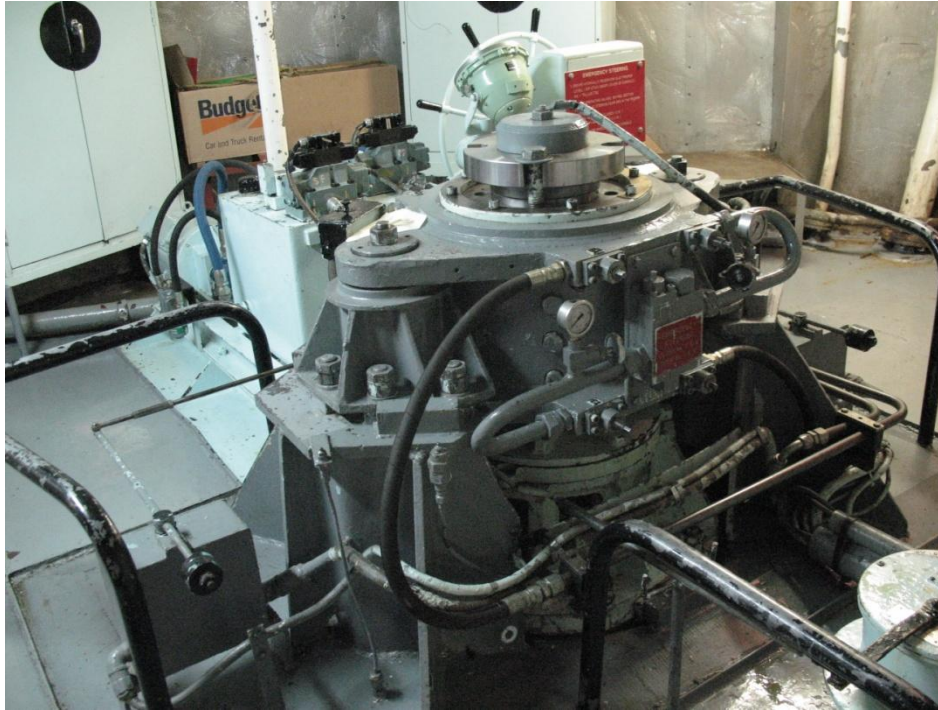
The steering compartment is well-preserved, well-maintained. The steering gear is a Brown Brothers rotary vane unit which shows no indication of excessive oil leakage or carrier bearing wear. The steering gear was not operated.

Figure 23: Steering motor

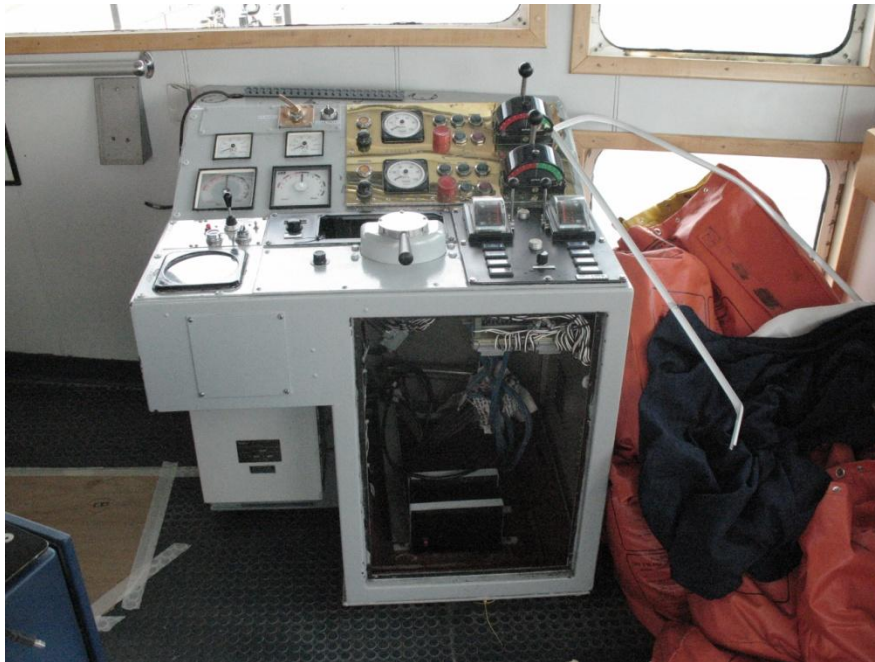
The two bridge wing propulsion control consoles have had some (unknown) components removed, but are otherwise intact and reported to be functional.

Figure 25: Stbd bridge wing maneuvering console

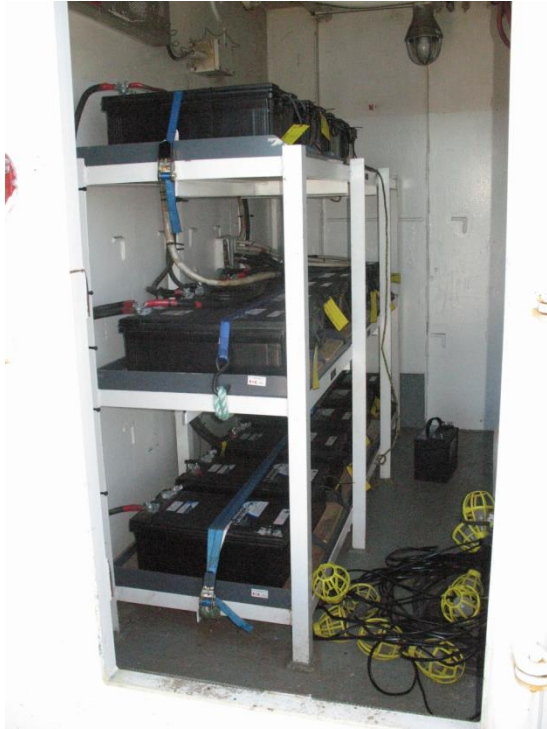
The battery room was clean and the 16 8D batteries appeared to be in good condition, and operating as the vessel's emergency communications power.

Figure 31: Battery room, boat deck
